## **Composite Failure Analysis Handbook Update #1**

*Greg Walker*

*Boeing Defense & Space Group*

**April 1995**

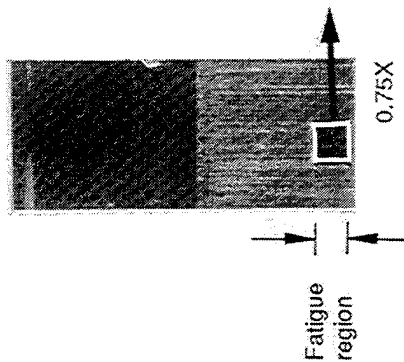
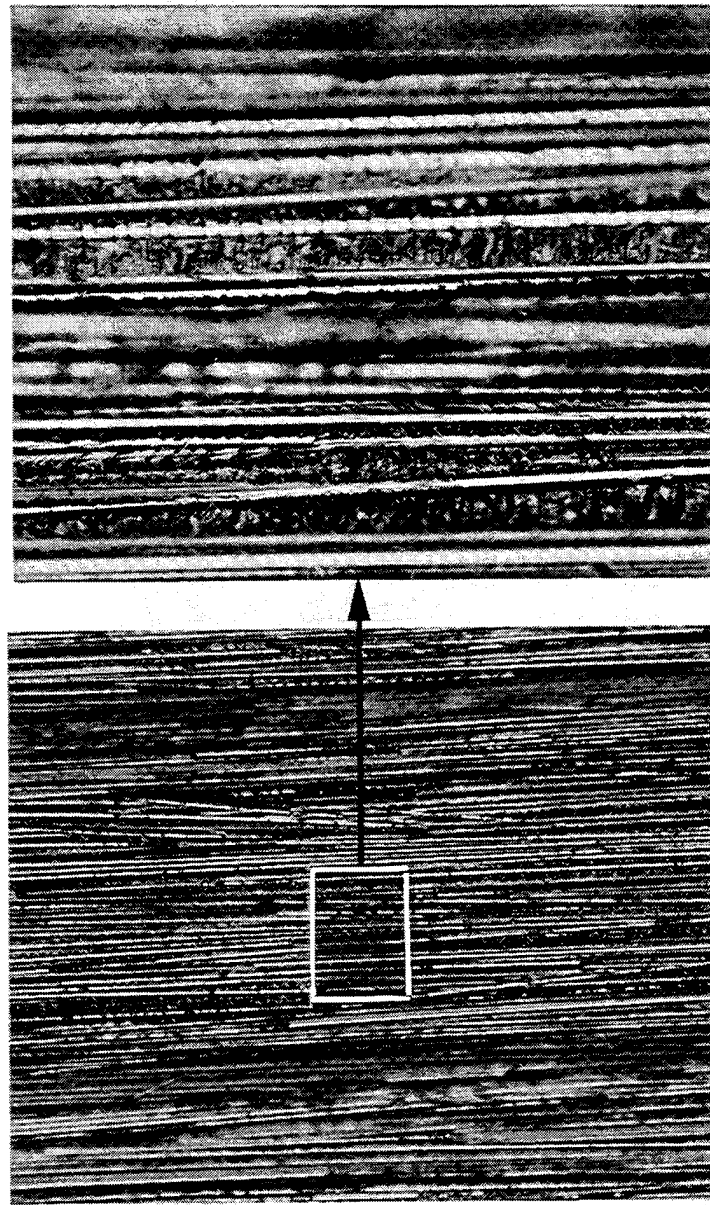
Figure 3.1-1 Optical Fractographs of 3501-6/AS4 Interlaminar Mode II (Shear) Fatigue, Low Stress Loading, 270°F

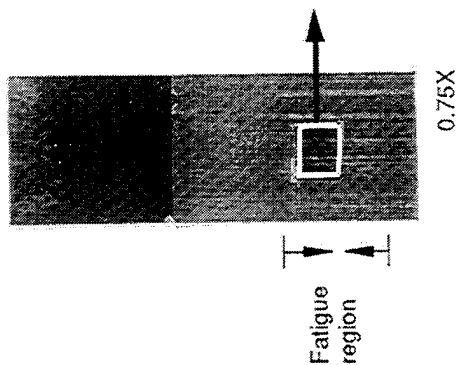
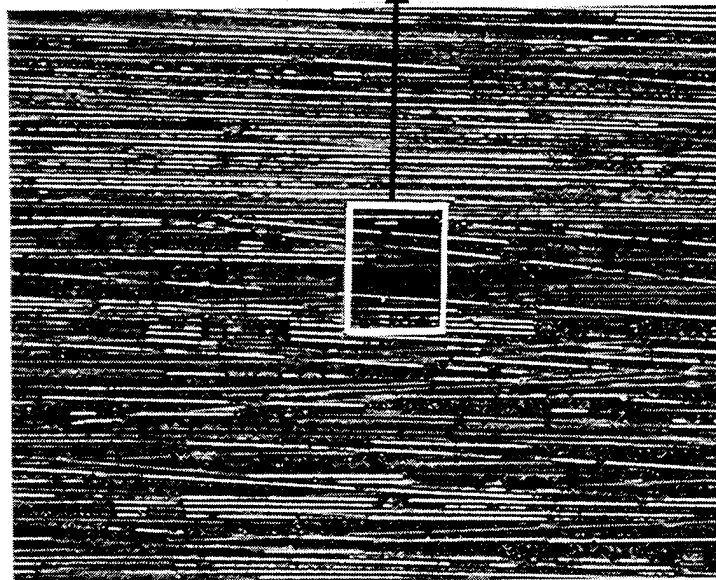
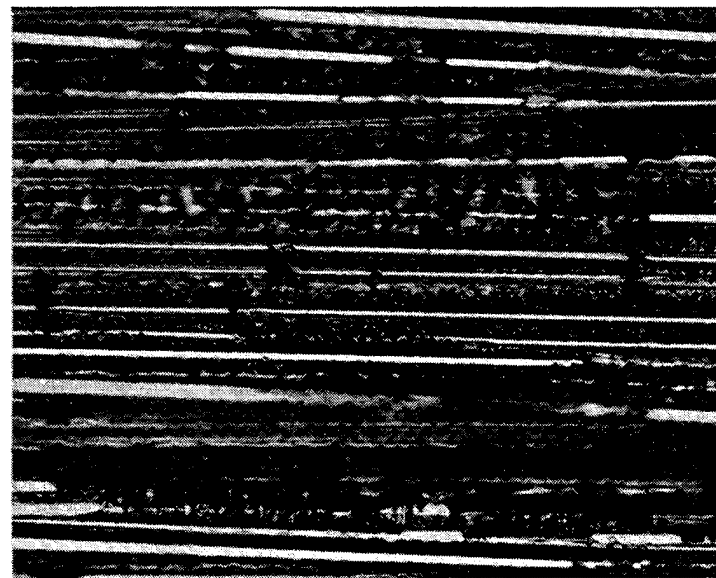
Figure 3.1-3. Optical Fractographs of 3501-6/AS4 Interlaminar Mode II (Shear) Fatigue, High Stress Loading, 270°F

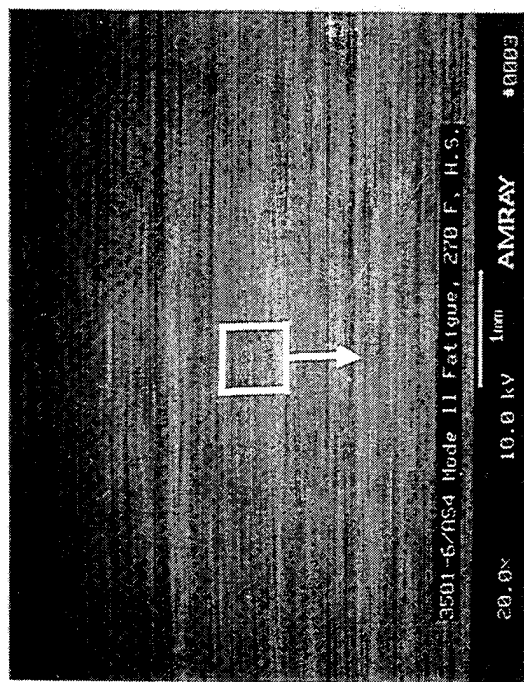
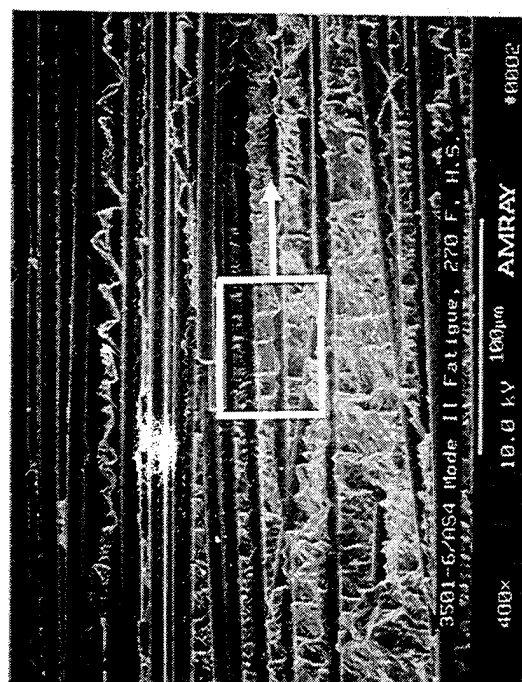
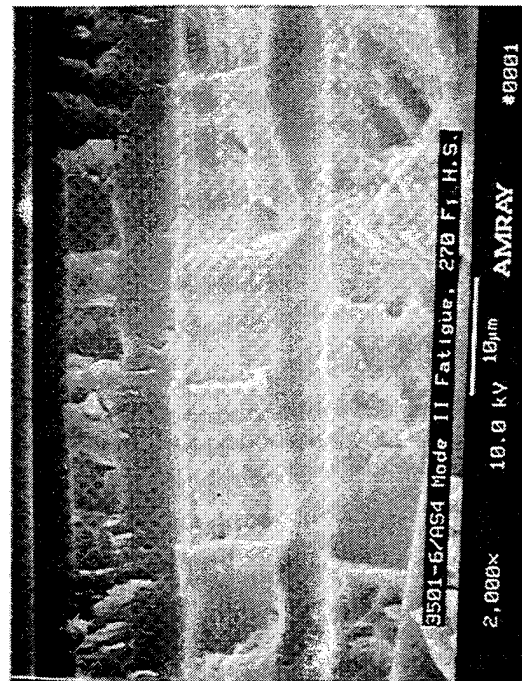
Figure 3.1-4. SEM Fractographs of a 3501-6/AS4 Interlaminar Mode II Fatigue Fracture Surface, High Stress, 270°F

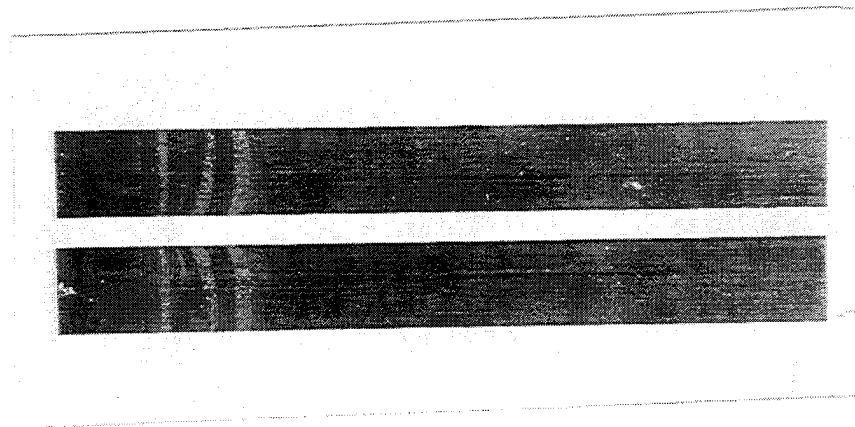
Figure 3.1-5. Optical Fractographs of a 3501/AS4 Interlaminar Mode I (Tensile) Fatigue Fracture Surface, 270° F

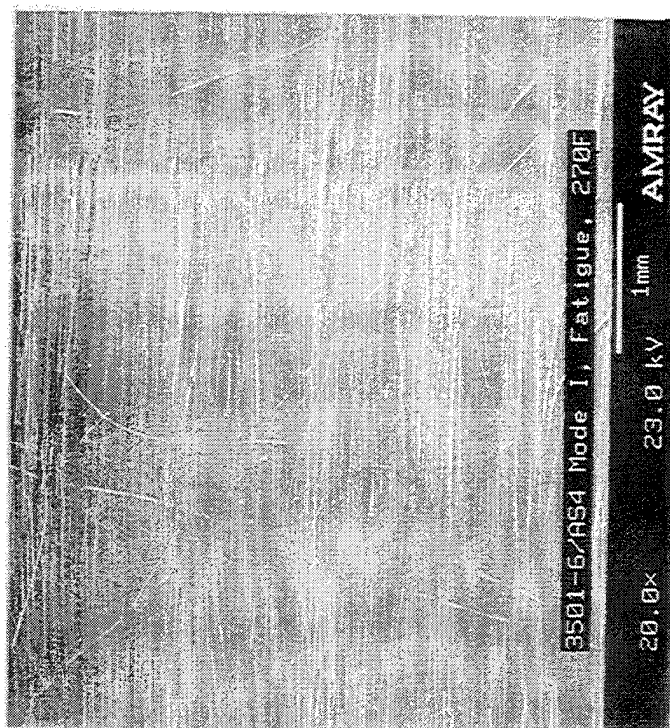
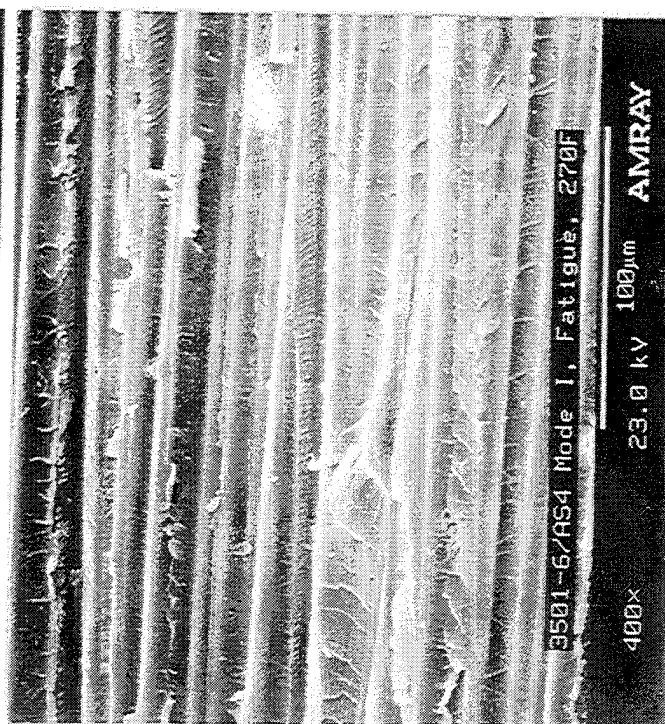
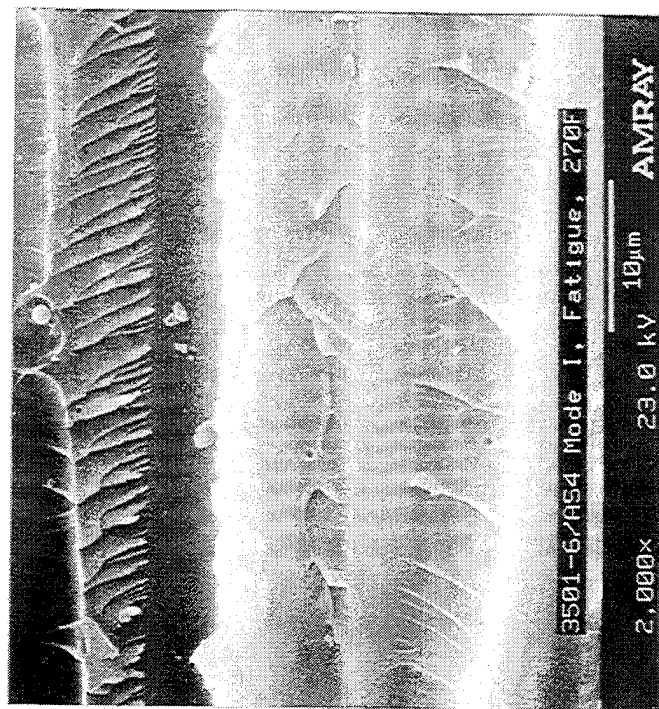
Figure 3.1-6. SEM Fractographs of a 3501/AS4 Interlaminar Mode I (Tensile) Fatigue Fracture Surface, 270° F

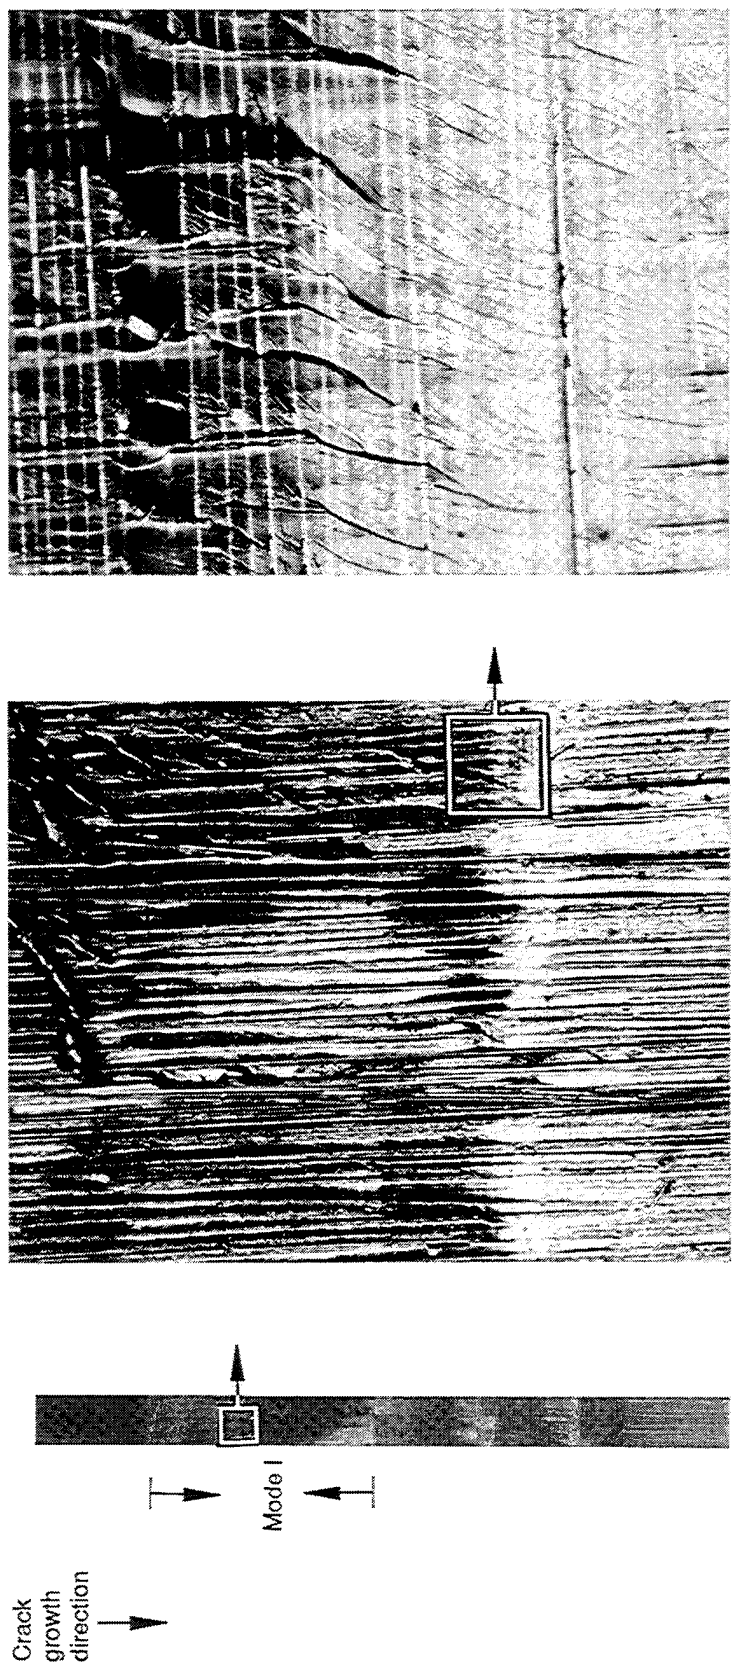
Figure 3.1-7. Optical Fractographs of 3501-6/AS4 Interlaminar Mode I Tension, Specimen Exposed to Deicing Fluid

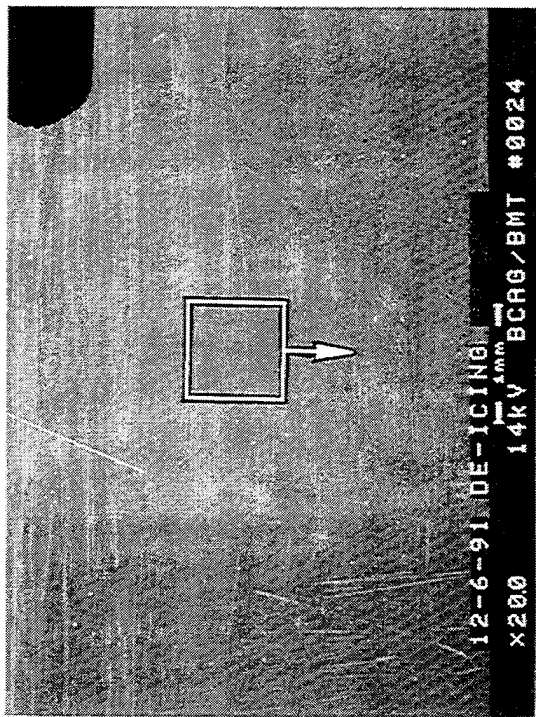
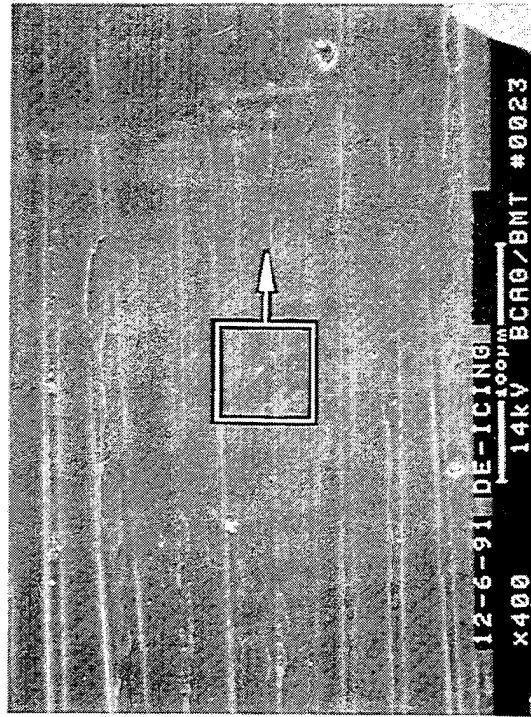
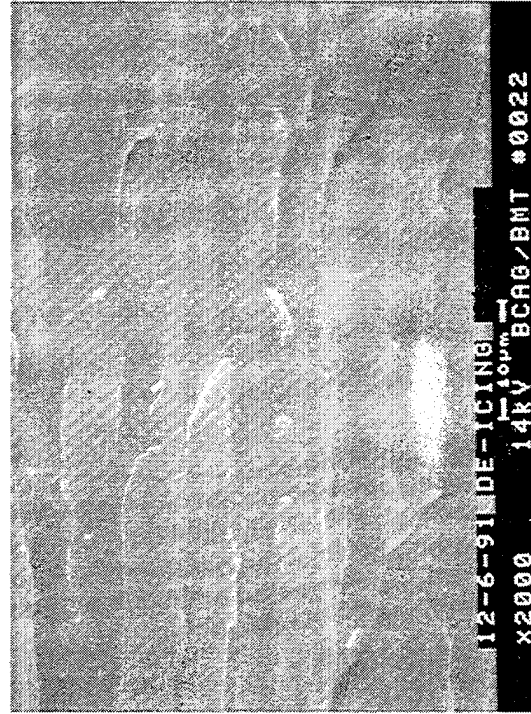
Figure 3.1-8. SEM Fractographs of 3501-6/AS4 Interlaminar Mode I Tension, Specimen Exposed to Deicing Fluid

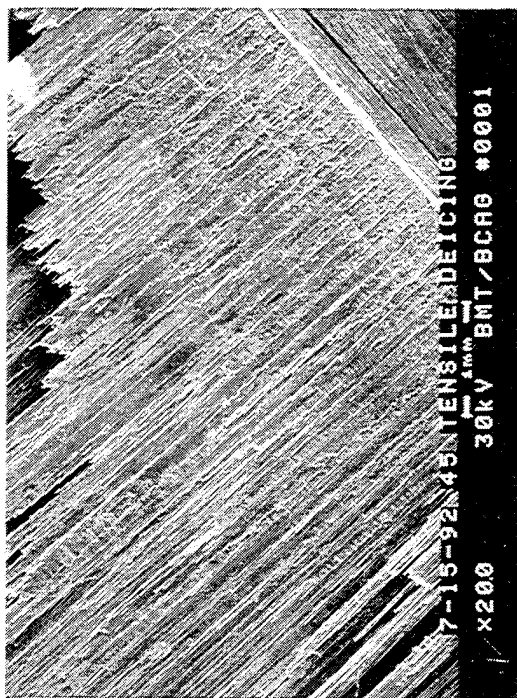
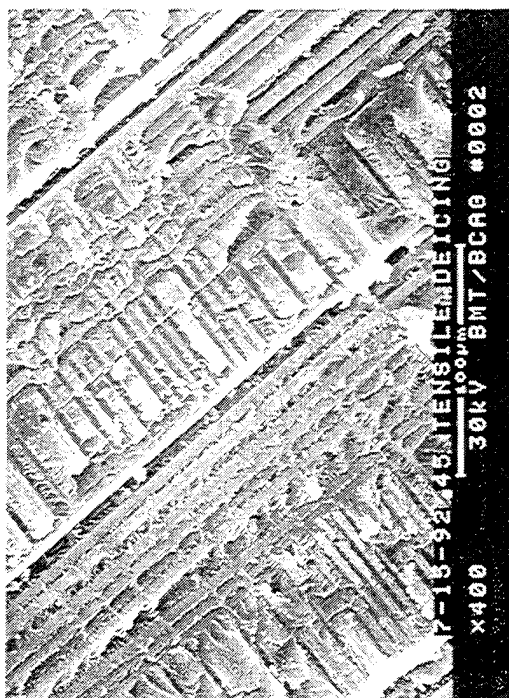
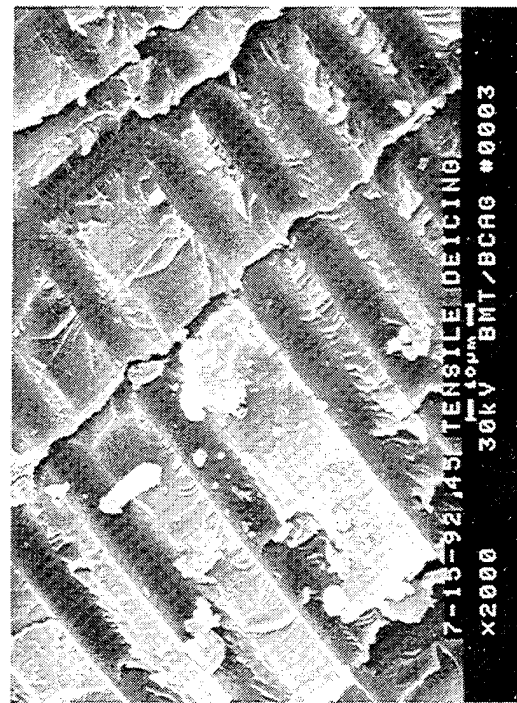
Figure 3.1-9. SEM Fractographs of a 3501-6/AS4 ± 45 Tensile Specimen Exposed to Deicing Fluid, Interlaminar Surface

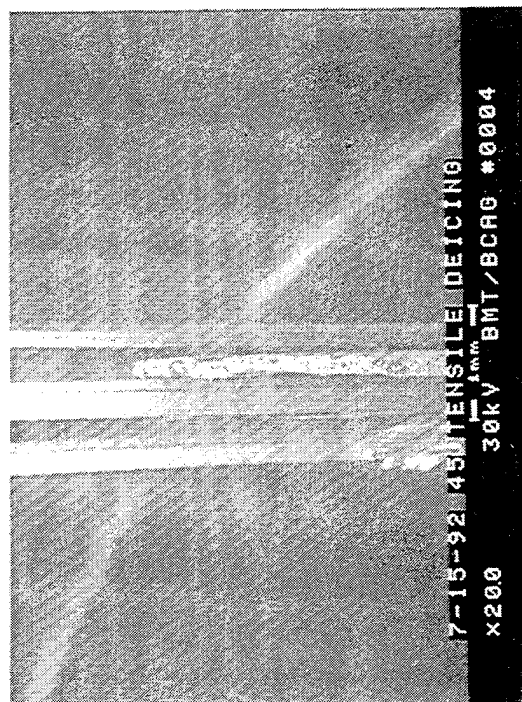
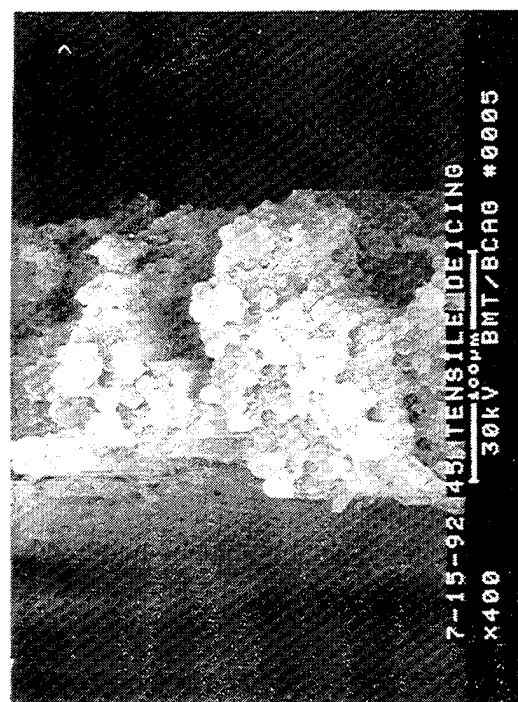
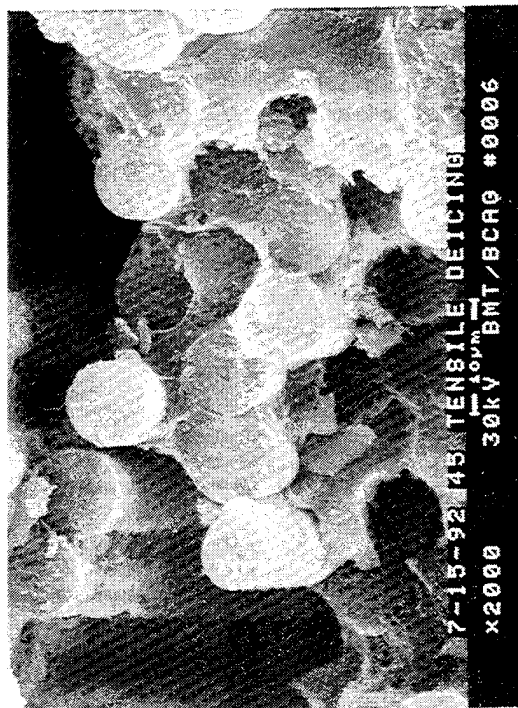
Figure 3.1-10. SEM Fractographs of a 3501-6/AS4 ± 45 Tensile Specimen Exposed to Deicing Fluid, Translaminar Surface

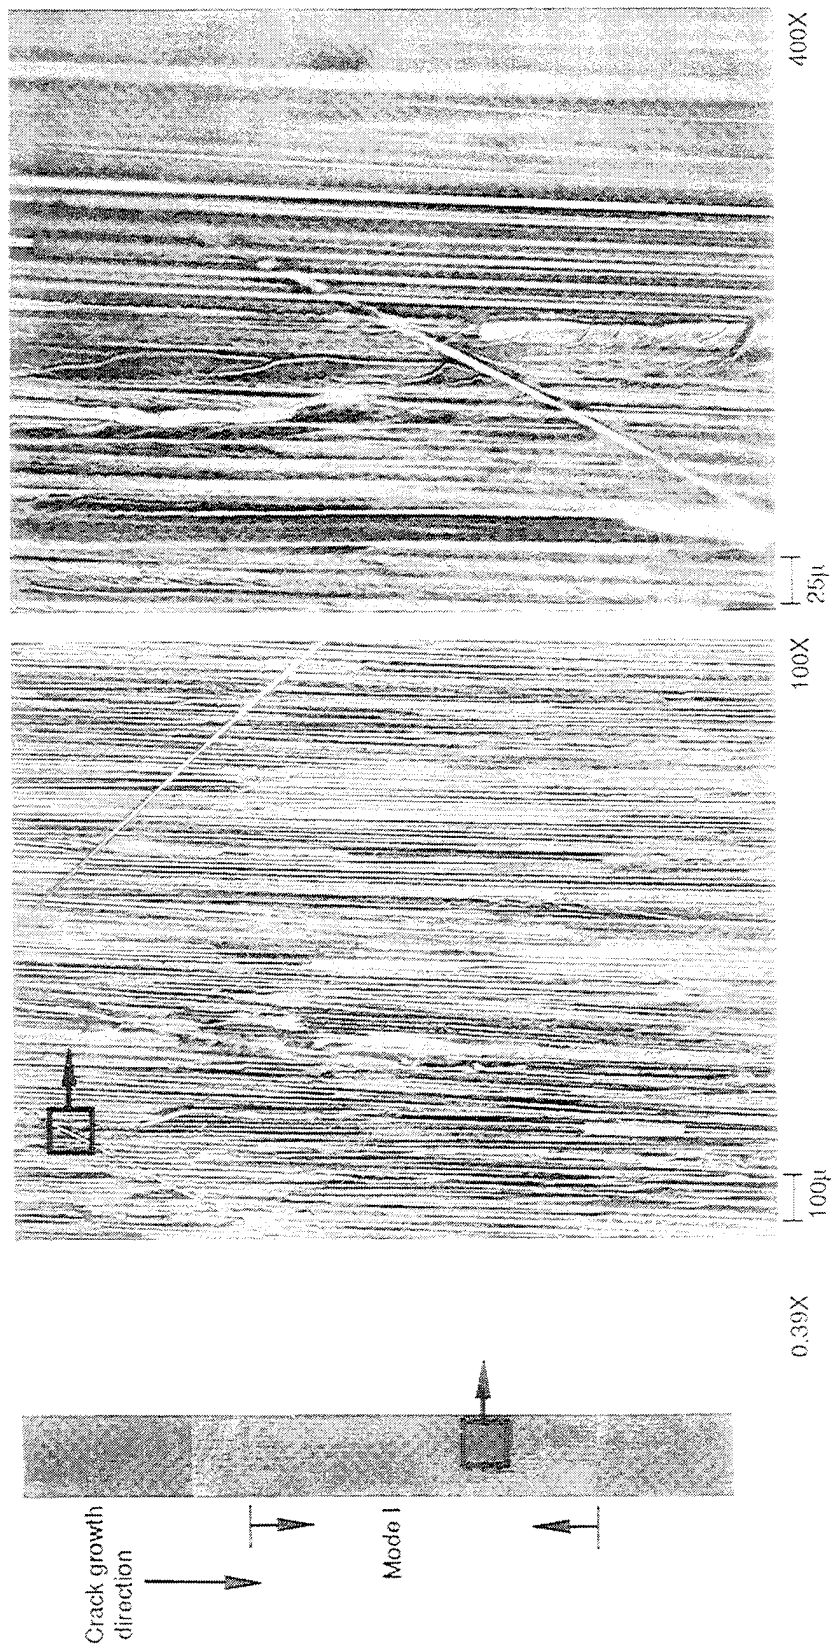
Figure 3.1-11. Optical Fractographs of 3501-6/AS4 Interlaminar Mode I Tension Specimen Tested at  $-20^{\circ}\text{F}$  (Freezing Condition)

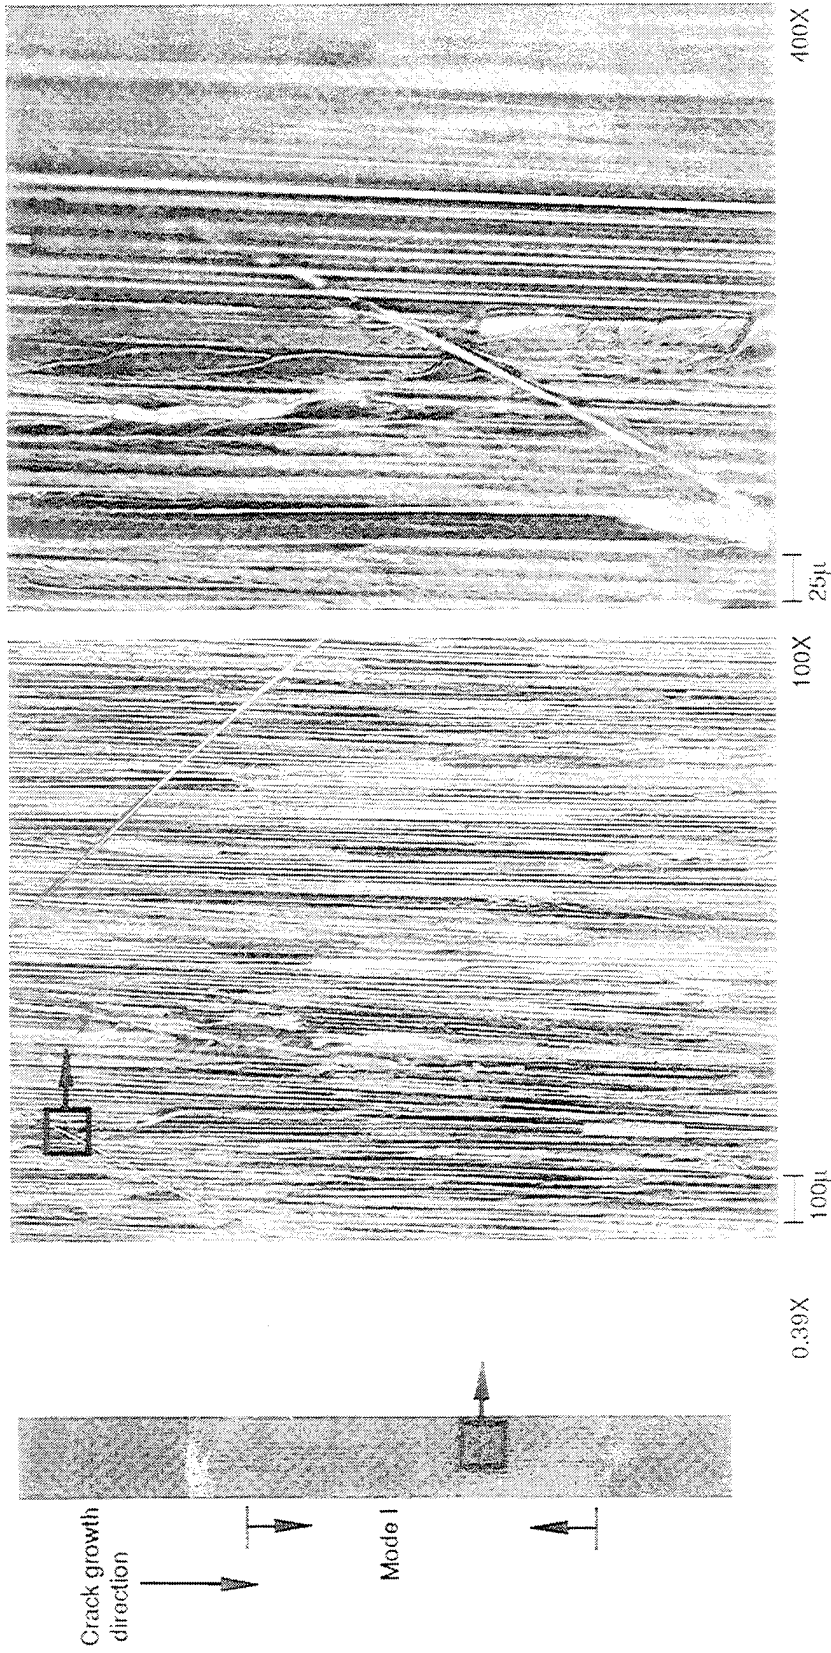
Figure 3.1-12. Optical Fractographs of 3501-6/AS4 Interlaminar Mode I Tension Specimen Tested at -20°F (Freezing Condition)

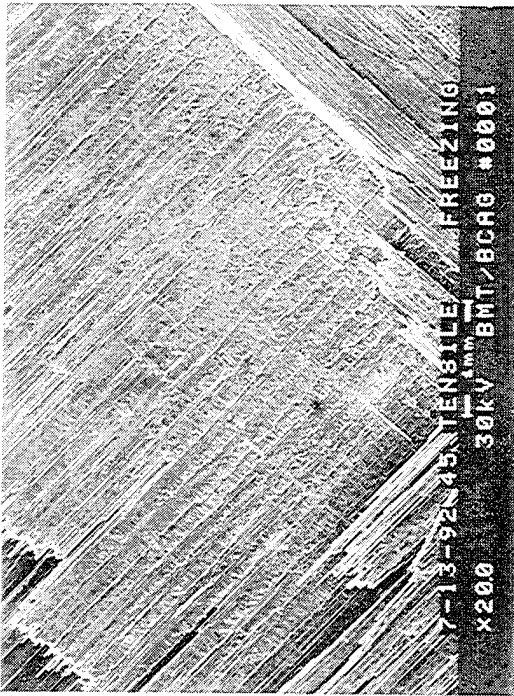
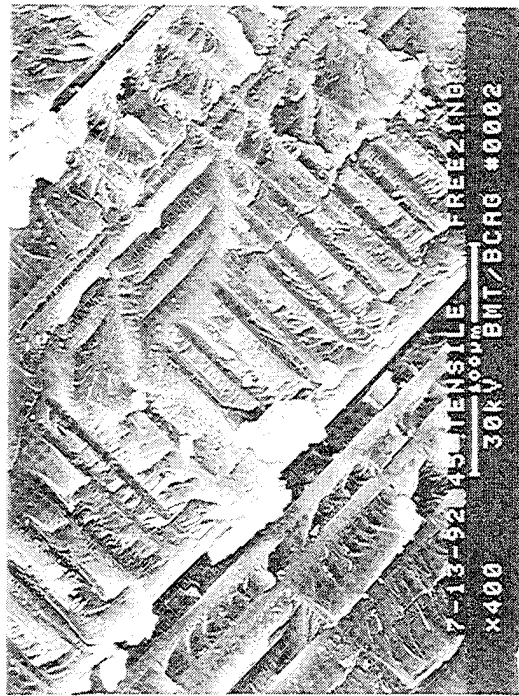
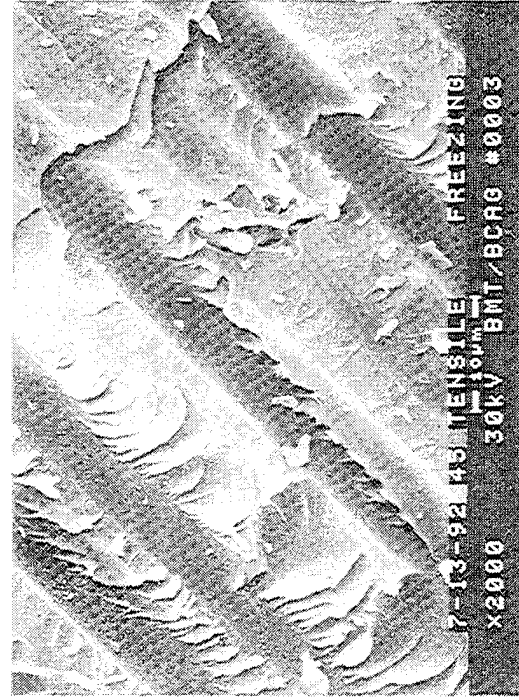
Figure 3.1-13. SEM Fractographs of a 3501-6/AS4  $\pm$  45 Tensile Specimen Tested at  $-20^{\circ}\text{F}$ , Interlaminar Surface

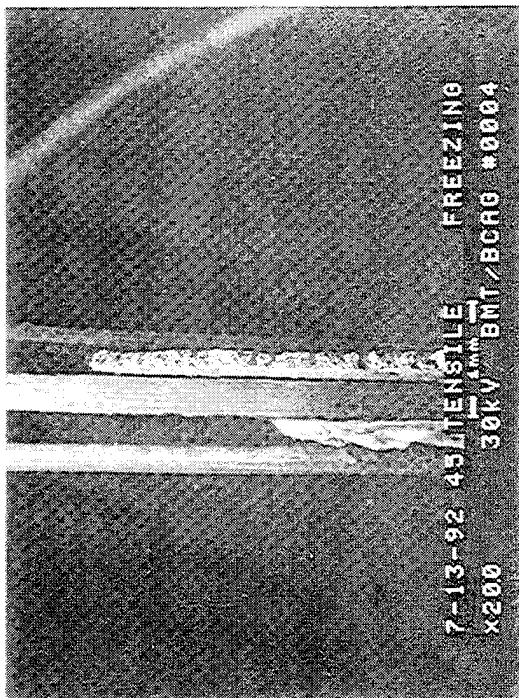
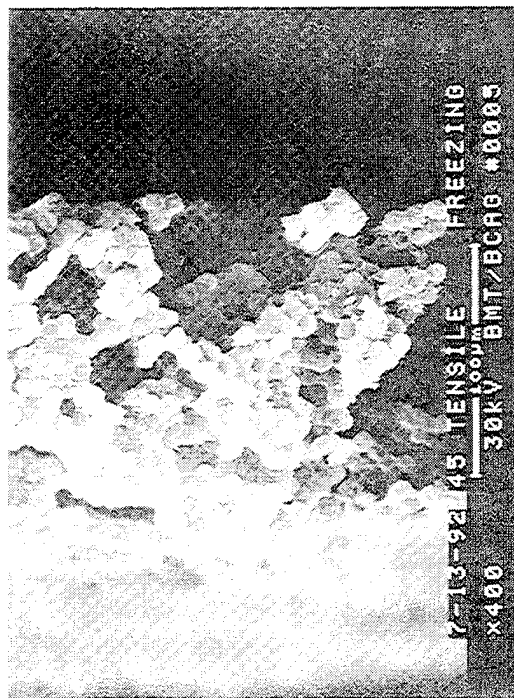
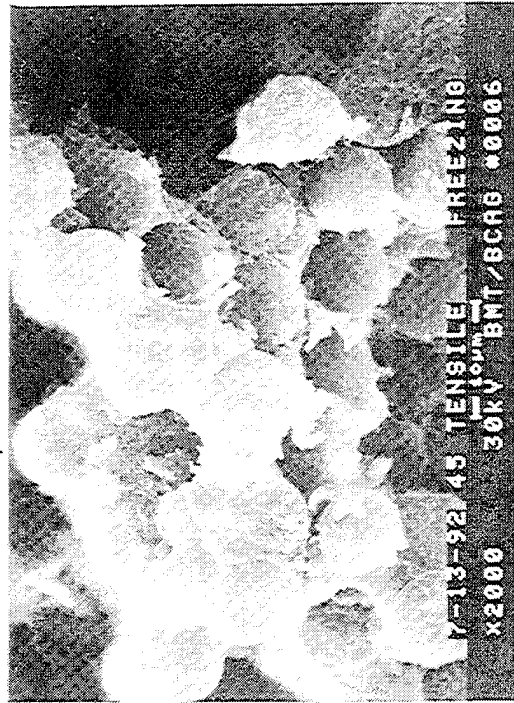
Figure 3.1-14. SEM Fractographs of a 3501-6/ASA  $\pm$  45 Tensile Specimen Tested at  $-20^{\circ}\text{F}$ , Translaminar Surface

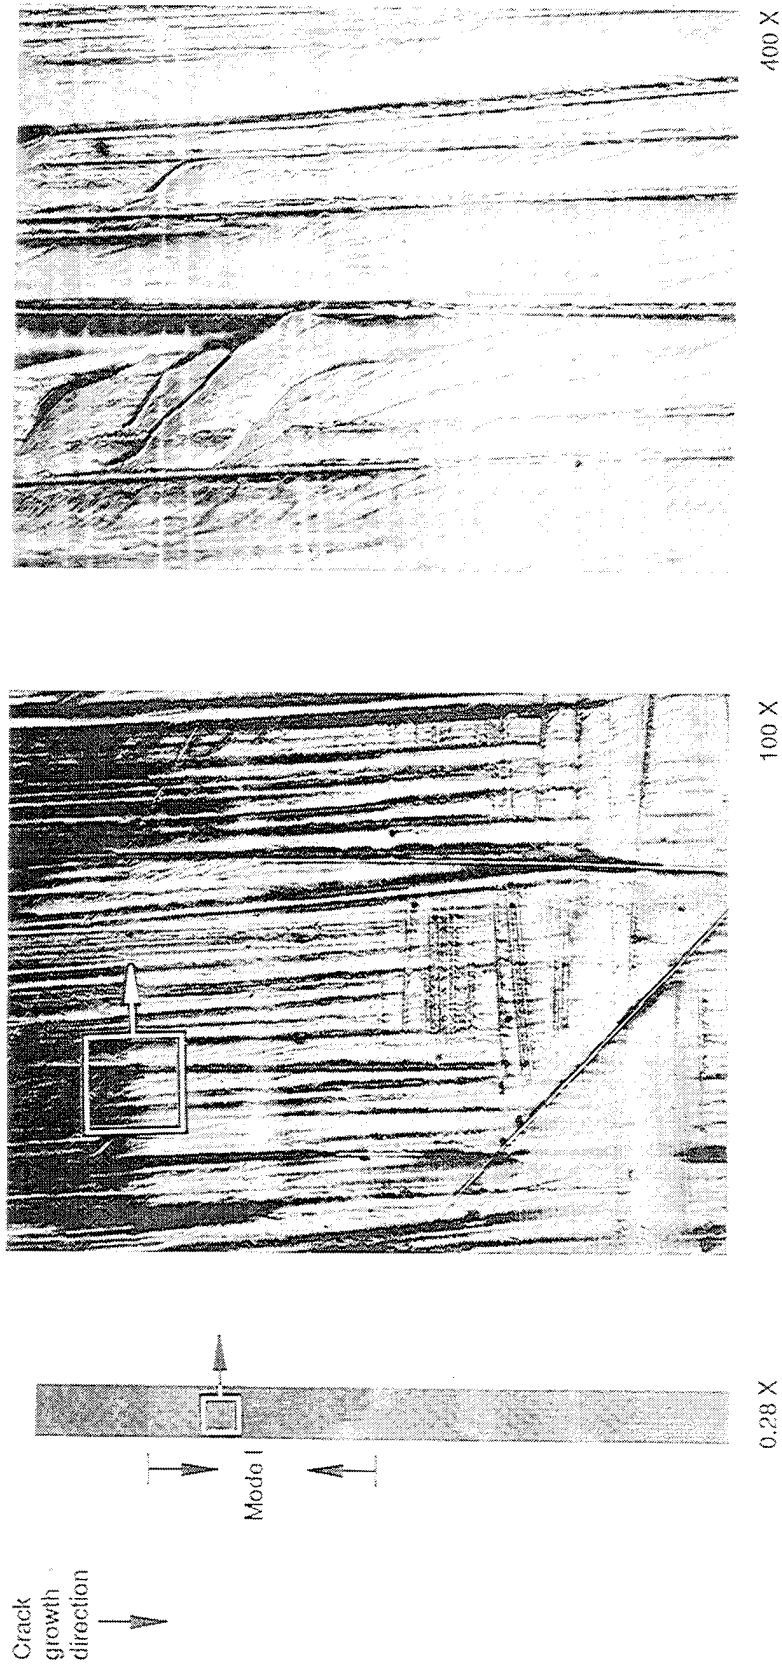
Figure 3.1-15. Optical Fractographs of 3501-6/AS4 Interlaminar Mode I Tension, Specimen Exposed to UV Radiation

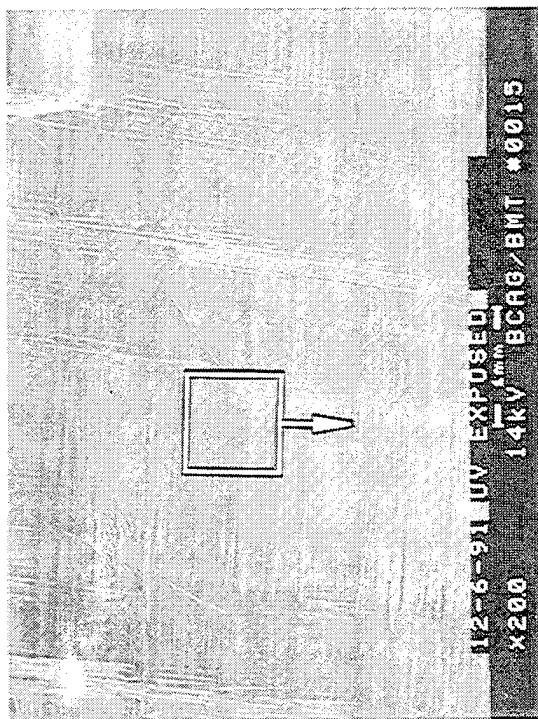
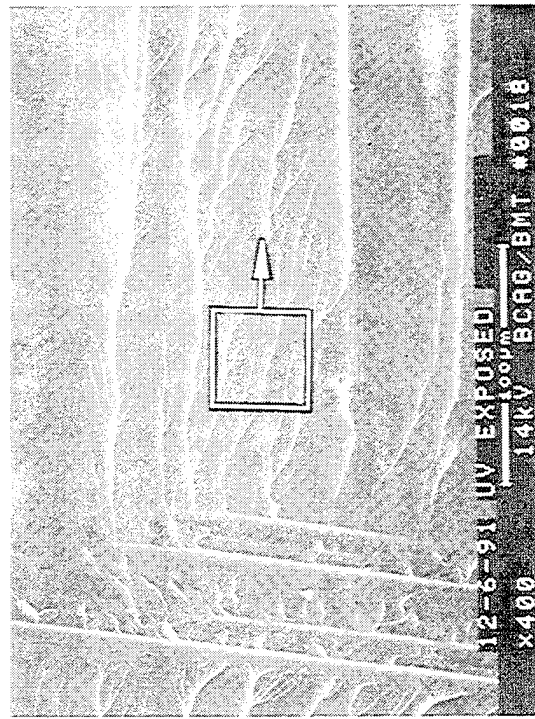
Figure 3.1-16. SEM Fractographs of 3501-6/AS4 Interlaminar Mode I Tension, Specimen Exposed to UV Radiation

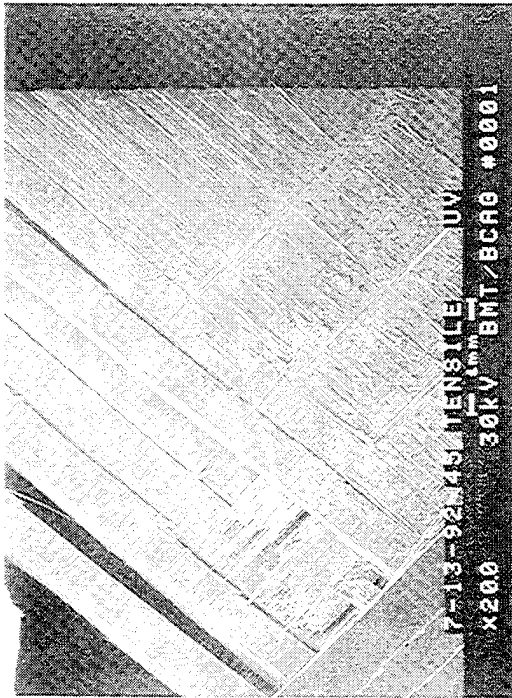
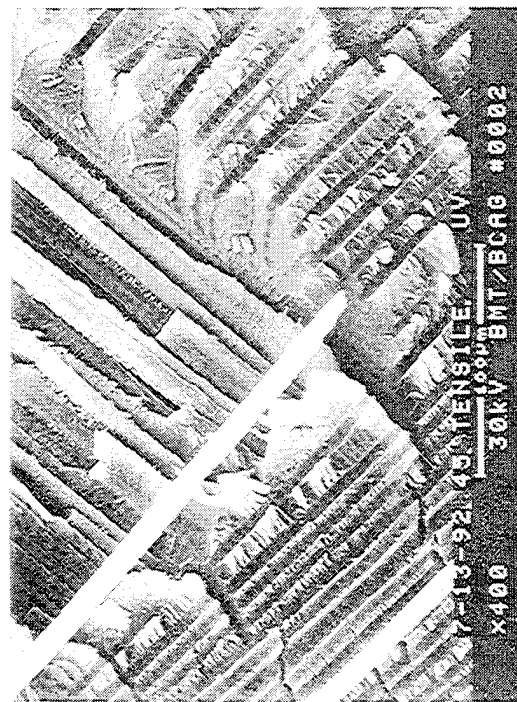
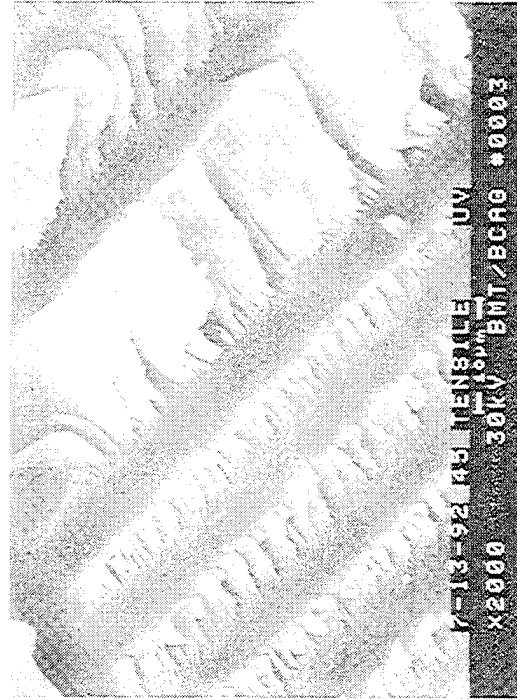
Figure 3.1-17. SEM Fractographs of a 3501-6/AS4 ± 45 Tensile Specimen Exposed to UV Radiation, Interlaminar Surface

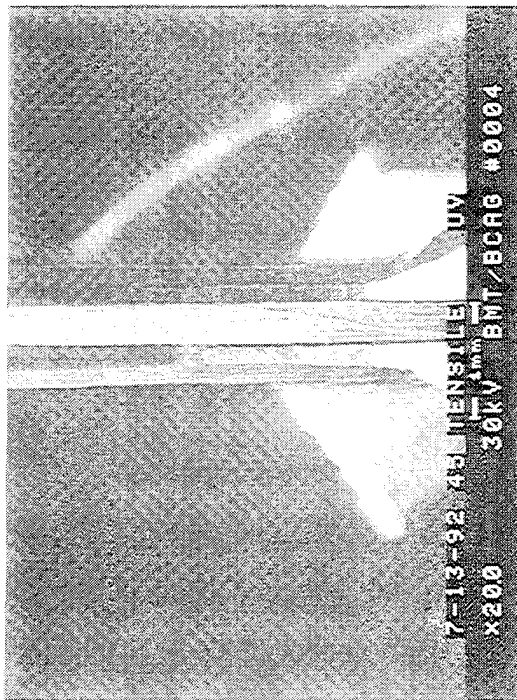
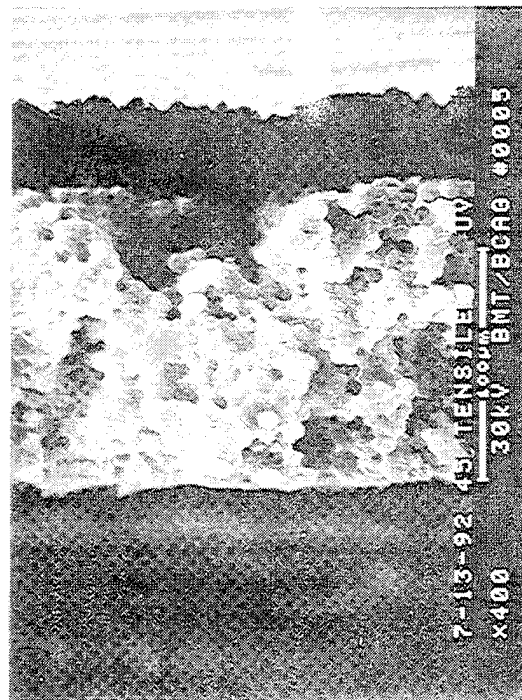
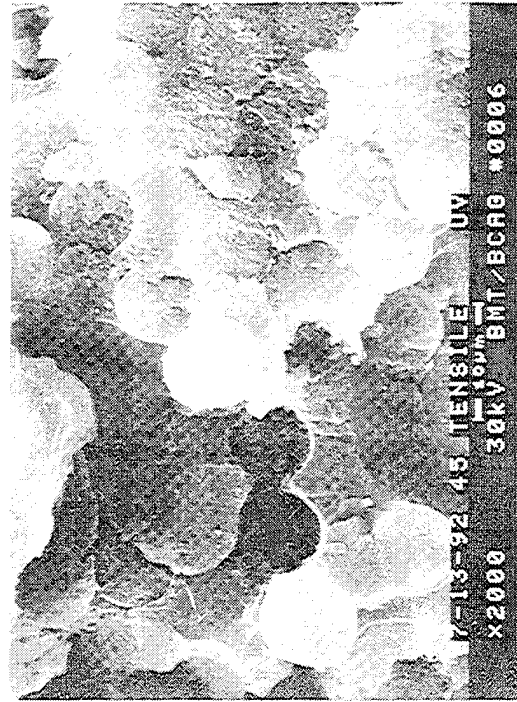
Figure 3.1-18. SEM Fractographs of a 3501-6/AS4 + 45 Tensile Specimen Exposed to UV Radiation, Translaminar Surface

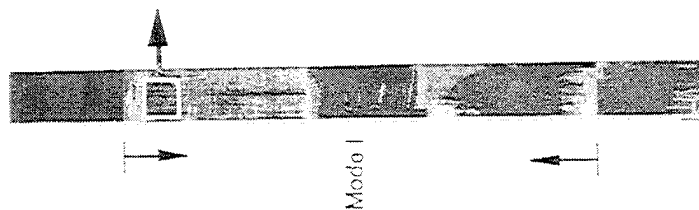
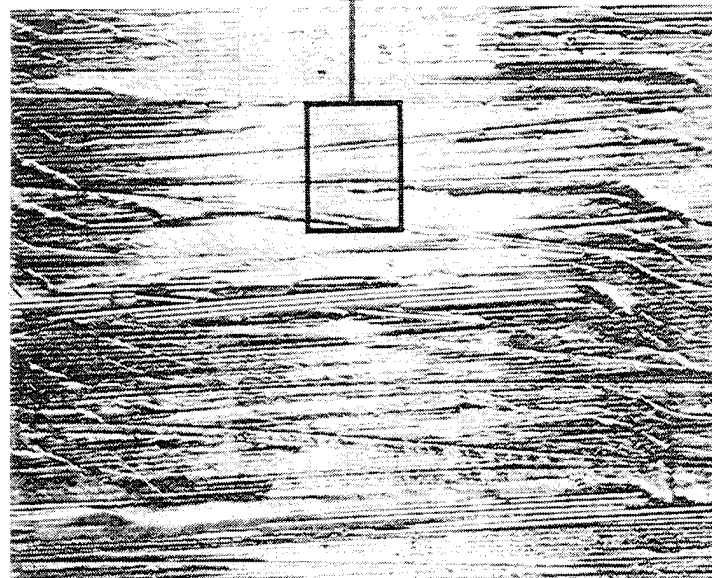
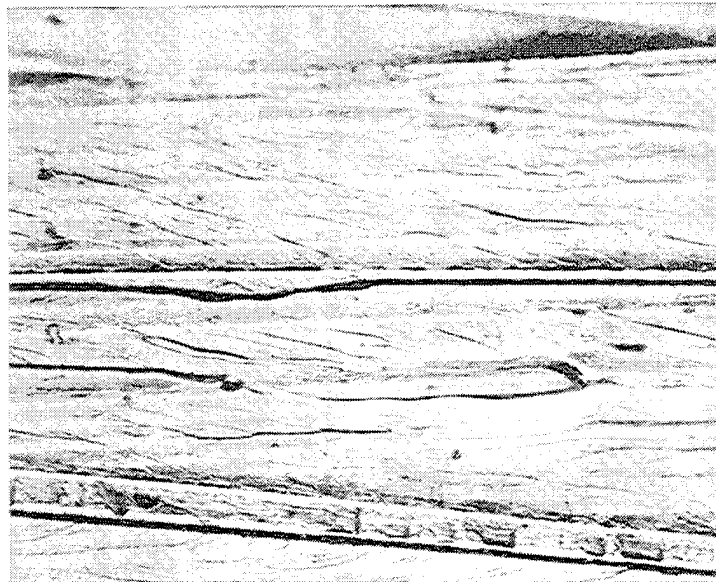
Figure 3.1-19. Optical Fractographs of 3501-6/AS4 Interlaminar Mode I (Tension), Specimen Thermally Cycled Prior to Loading

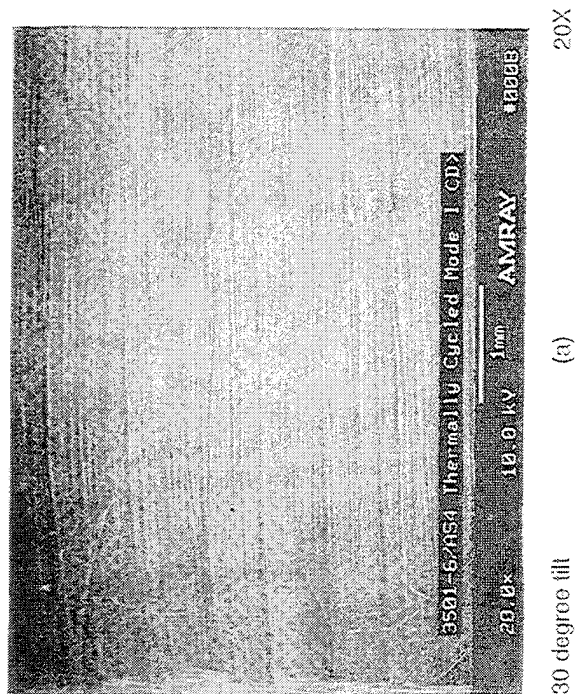
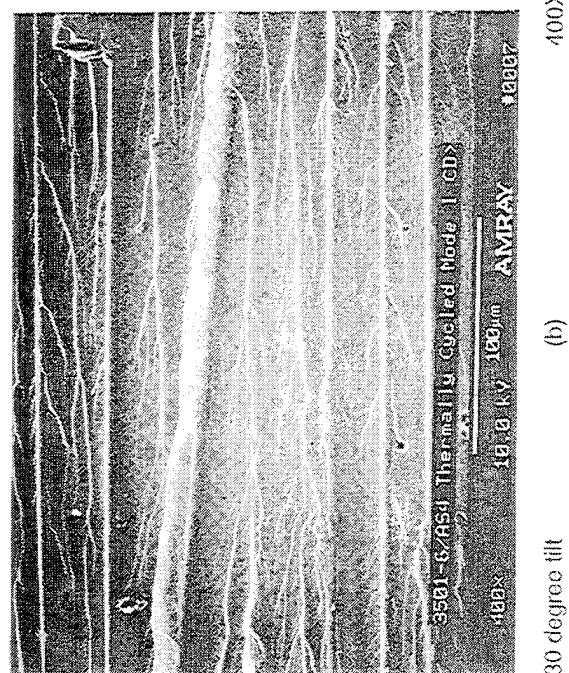
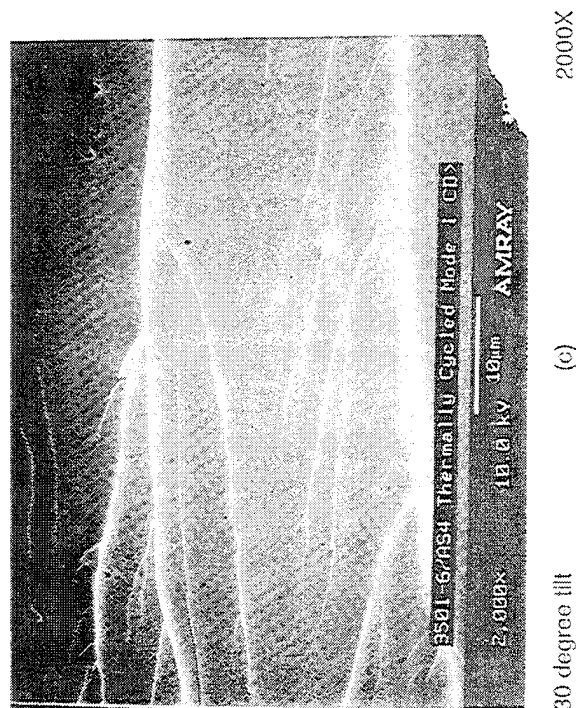
Figure 3.1-20. SEM Fractographs of a 3501-6/AS4 Interlaminar Mode I Tension Fracture Surface, Thermally Cycled.

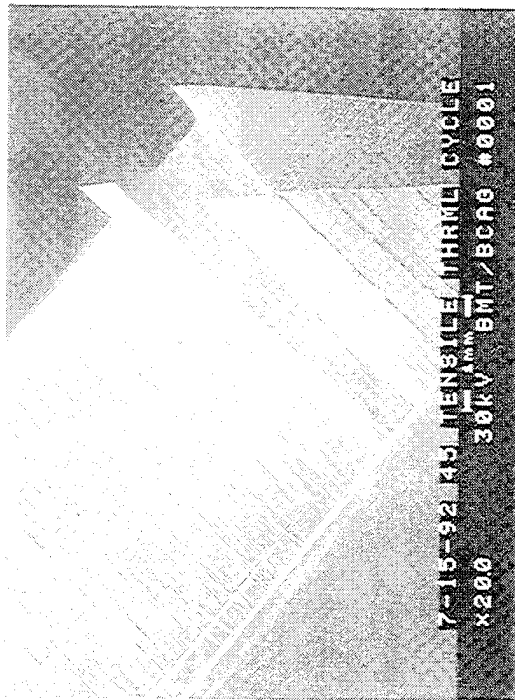
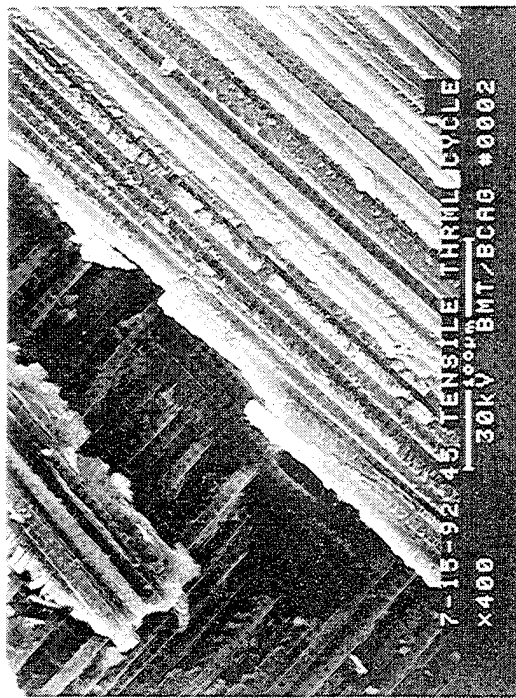
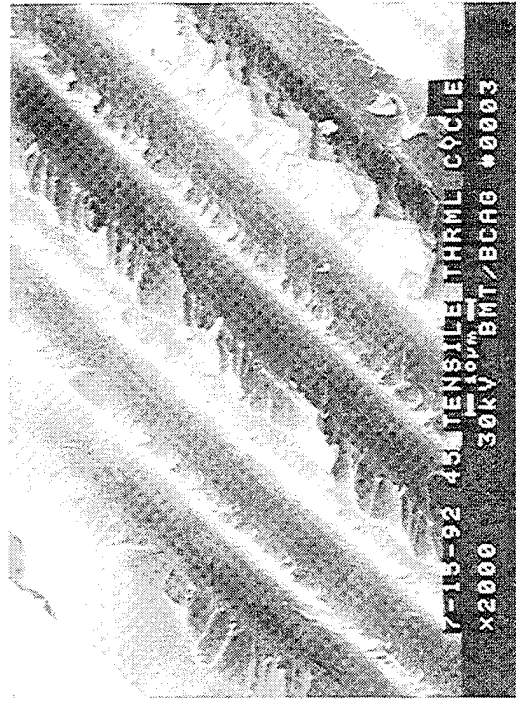
Figure 3.1-21. SEM Fractographs of a 3501-6/AS4 ± 45 Tensile Specimen Thermally Cycled, Interlaminar Surface

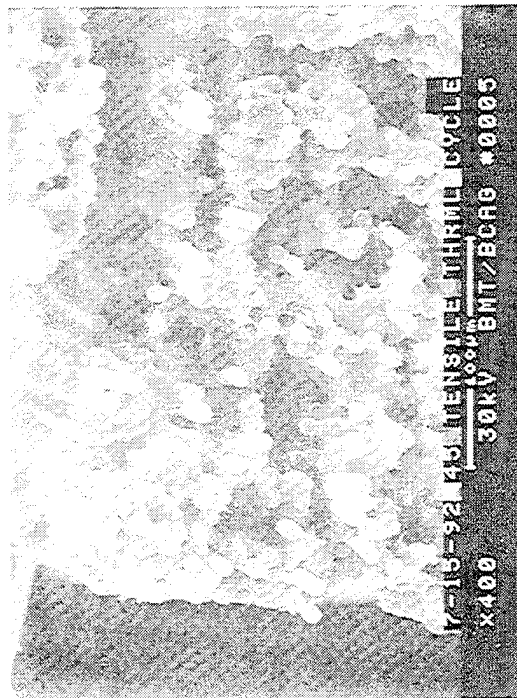
Figure 3.1-22. SEM Fractographs of a 3501-6/AS4 ± 45 Tensile Specimen Thermally Cycled, Translaminar Surface
